Manhole Inspection Summary

Manhole # S35CC_019MH

Location Address: **114 e. eager st**

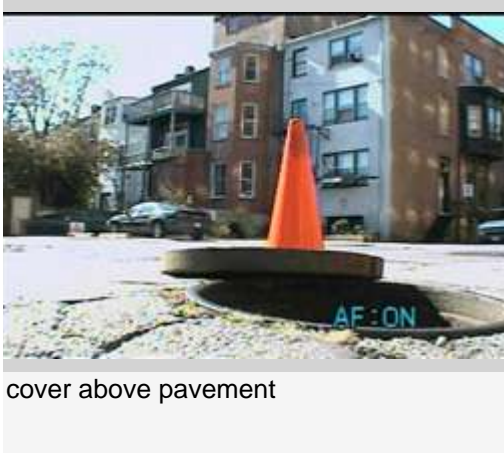
Defect 2

cover above pavement

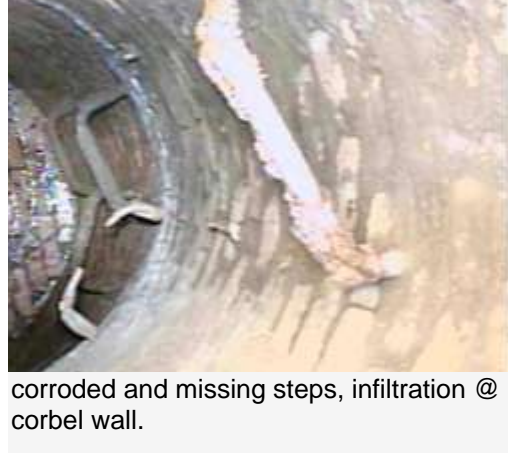
Defect 1

Infiltration: ☐ None ☐ Joint ☐ Cracks ☐ Mortar ☐ Roots ☒ **Wall**

Count: **6**

Missing: **2**

☒ **Corroded**

corroded and missing steps, infiltration @ corbel wall.

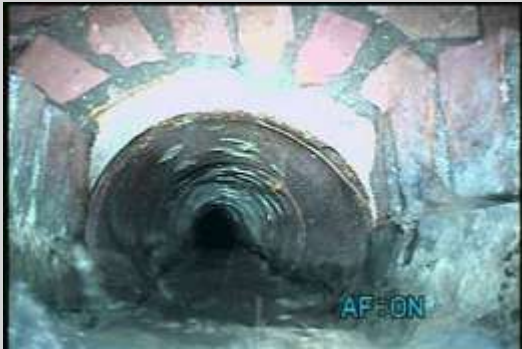
12 O'Clock Outflow

10 in. Circular Gravity Sewer
Pipe Out @ 12 O'Clock

Invert Depth: 11.35 (ft.) Flow Characteristics: **Turbulent**

Infiltration: **None** Pipe Seal Cond: **Unknown**

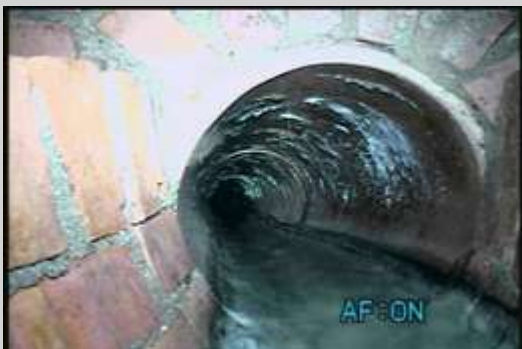
3 O'Clock Inflow

10 in. Circular Gravity Sewer
Pipe In @ 3 O'Clock

Invert Depth: 11.15 (ft.) Flow Characteristics: **Turbulent**

Infiltration: **None** Pipe Seal Cond: **Unknown**

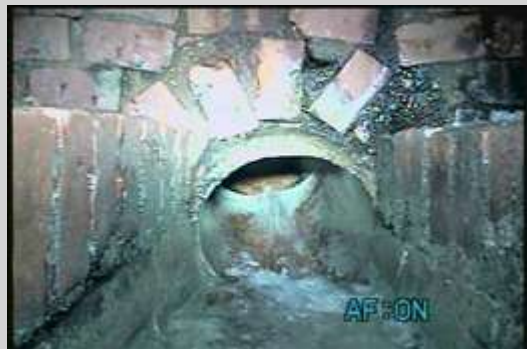
6 O'Clock Inflow

8 in. Circular Gravity Sewer
Pipe In @ 6 O'Clock

Invert Depth: **11.15** (ft.) Flow Characteristics: **Turbulent**

Infiltration: **None** Pipe Seal Cond: **Unknown**
